## PROPERTIES AND STABILITY OF A TEXAS BARRIER BEACH INLET

Prepared by  
CURTIS MASON and ROBERT M. SORENSEN  
Departments of Oceanography and Civil Engineering  
Texas A&M University

August 1971

TAMU-SG-71-217

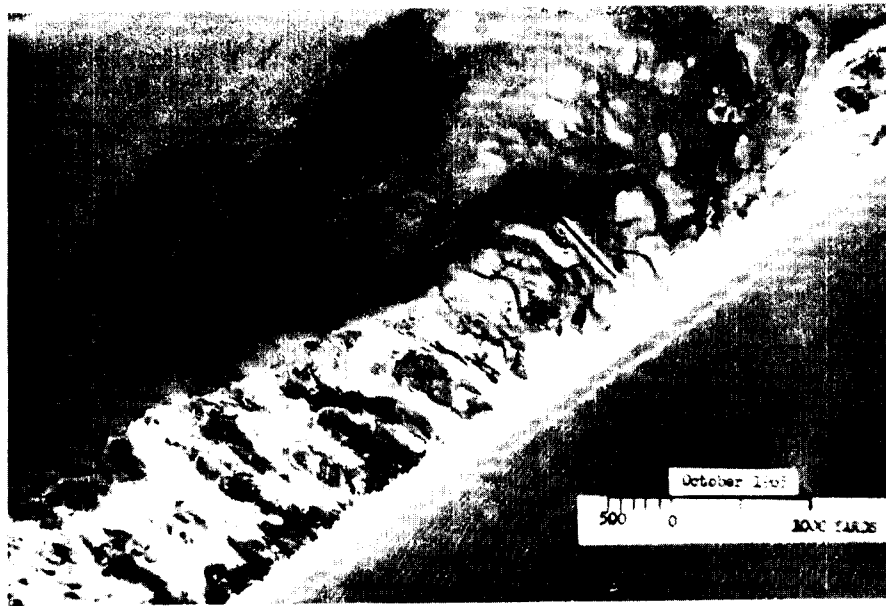
FIGURE 20. SITE OF BROWN CEDAR CUT, OCTOBER, 1965.  
(PHOTO COURTESY USDA)

1965, Figure 20: In 1965, attempts were made by local citizens to reopen the inlet. Using a bulldozer and a drag-line dredge, a long narrow channel was excavated to connect the bay and gulf. This channel remained open about one week, and then filled with sand. Remnants of the channel can be seen in the left center of Figure 20.

Since its formation, Brown Cedar Cut has exhibited a marked tendency for both geometric and geographic instability. A typical sequence of events characterizes the inlet's response to natural forces on the Gulf coast: The action of large waves and high tides associated with hurricanes, or large amounts of rainfall and runoff, establish a wide, relatively deep channel. This channel has consistently occupied a position very close to the location exhibited on October 24, 1970, as shown in Figure 70. Following this enlargement, the erosive forces of strong currents and high waves are diminished. The inlet mouth migrates westward in response to dominant depositional processes, which produces growth of a large spit on the east side. The rate of inlet migration depends upon the magnitude and duration of the waves from the east and southeast which produce the littoral drift. As the channel lengthens, tidal velocities decrease, and siltation occurs throughout the channel. If undisturbed, migration may continue until the inlet becomes greatly extended, as indicated in Figure 18. At such time, the interchange of gulf and bay waters is effectively nonexistent. However, such extension does not appear to be common. Generally the channel is re-enlarged by waves or currents, the east spit is greatly eroded, and the sequence is repeated. Actual closing of the inlet occurred only between 1964 and 1967, as illustrated in

Figure 20. Apparently wide scale enlargement and shoaling of the inlet by Hurricane Carla initiated irreversible closure tendencies.

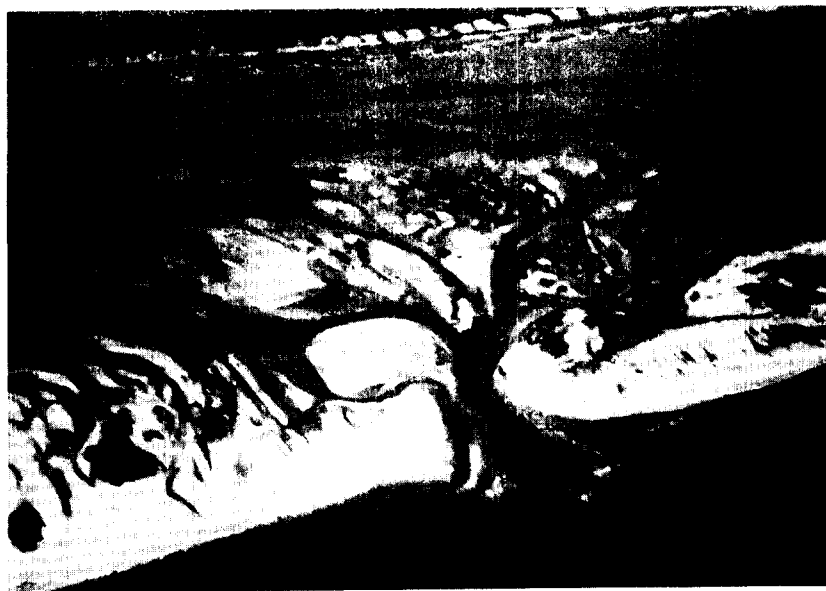
FIGURE 22. BROWN CEDAR CUT, JUNE, 1969.  
(PHOTO COURTESY TEXAS PARKS & WILDLIFE)

1969, Figure 22: Although no major storms were reported between November, 1967, and June, 1969, it appears that the inlet

maintained satisfactory geographic stability. It is unfortunate that a 1967 post-Beulah photograph was not available, for the inlet must have been of significant proportions and quite deep. Note that almost no spit building has occurred on the northeast side and than only minor shoal areas flank the main channel outside the mouth.

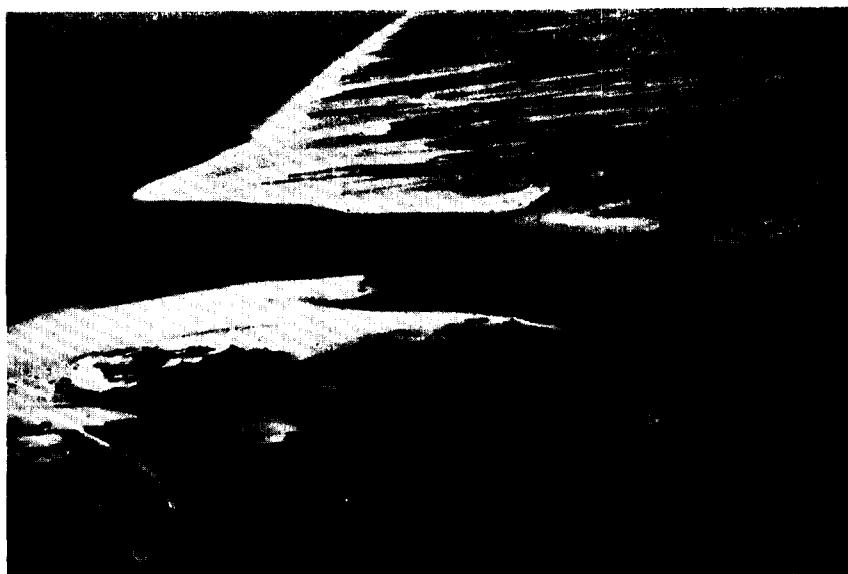
FIGURE 23. BROWN CEDAR CUT, NOVEMBER, 1970.  
(AUTHOR'S PHOTO)

1970: Hurricane Celia, which struck the Corpus Christi area in August, produced a storm surge of about two feet at Brown Cedar Cut, and wave activity was great. A wide channel was observed shortly after Celia's passage, and it did not significantly alter shape prior to the first survey conducted by the author in October, 1970. The inlet configuration in November is presented in Figure 23, but modifications which occurred after October will be discussed in a later section.
